# **Rocky Flats Site, Colorado, Quarterly Report of Site Surveillance and Maintenance Activities Third Quarter Calendar Year 2017**

**January 2018**

**U.S. DEPARTMENT OF  
ENERGY**

Legacy  
Management

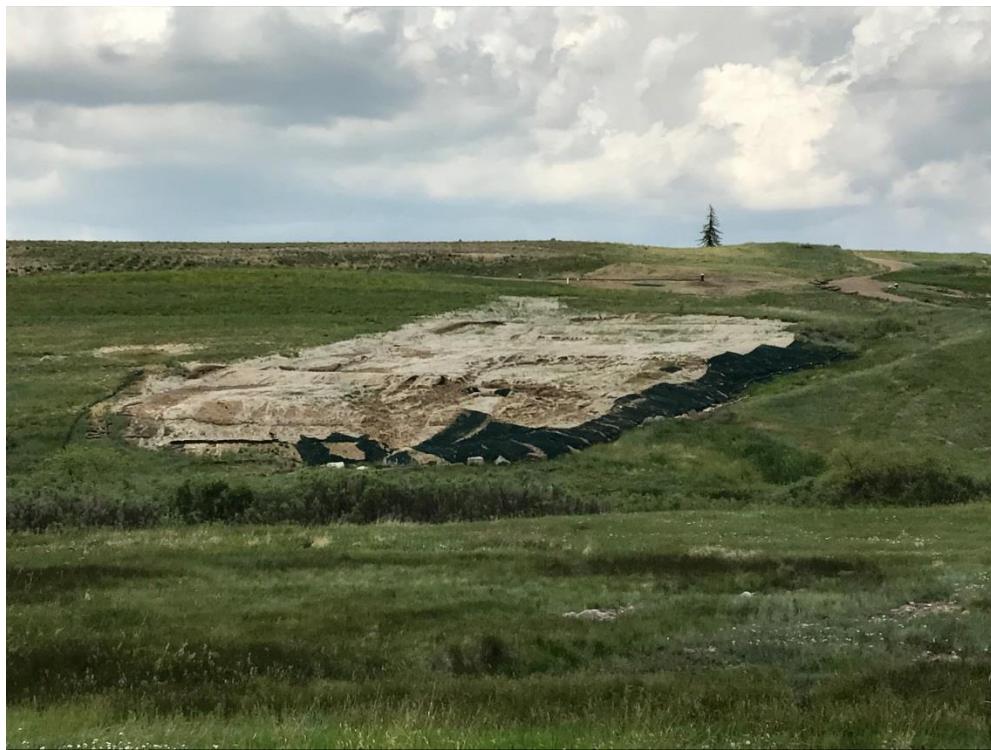
The slump begins above berm 6, runs through berm 7, and terminates at the East Perimeter Channel (EPC) outfall (Figure 2). It is approximately 130 feet (ft) wide (east–west) and 200 ft long (north–south) and has approximately the same boundary as the 2016 slump area. Minor propagation of the slump was observed this month when a new crack was discovered outside the OLF waste footprint. The crack is approximately 38 ft long and located approximately 8 ft west of the previously reported western edge of the slump (Figure 3). The crack has been photographed and included in Figure 1 as “New crack adjacent to slump found 7/19/17.” No further movement of the crack through berms 6 or 7 or through the center of the slump (Figure 4) has been observed. A crack above berm 4 was reported last month and has been backfilled. It is possible that this crack is also a sign of propagation upgradient of the slump, and it will be monitored as such. Slump movement will continue to be monitored and recorded.

**Figure 2: Looking North Toward Slump on June 13, 2017**

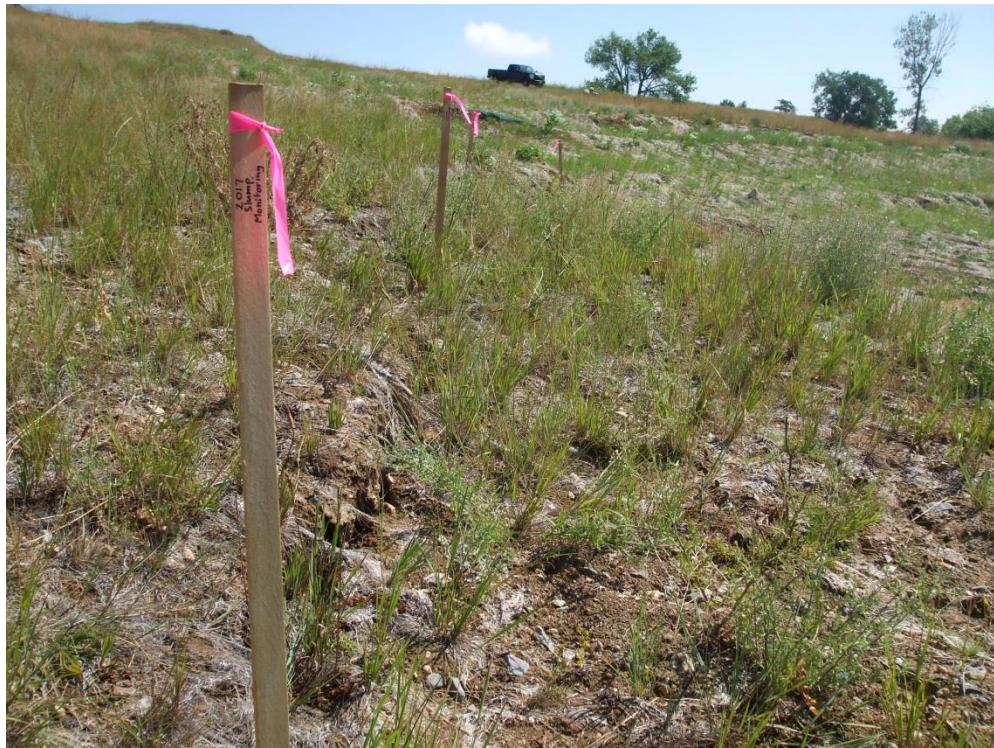
A new crack was discovered approx. 8 feet <sup>west of</sup> <sub>from</sub> <sup>NK</sup> <sub>7/25/17</sub> previous western edge of 2017 slump and is approx. 38 feet in length. [Rocky Flats Met tower recorded 0.20 inches of rain since last monthly report. NREL MZ tower recorded 0.24 inches during same period] <sup>NK</sup> <sub>8/14/17</sub>

Figure 3: Looking Northeast at New Crack, Approximately 38 Feet Long, Discovered Approximately 8 Feet West of Previous Western Edge of Slump (See Figure 1)

DEFICIENCY	DATE NOTED	ACTION	DATE COMPLETED	COMMENTS
Erosion of backfill above Berm <sup>5</sup>	7/20/2017	backfilled with hand tools	7/21/17	
Crack west of Slump's west edge	7/20/2017	backfilled with hand tools	8/10/17

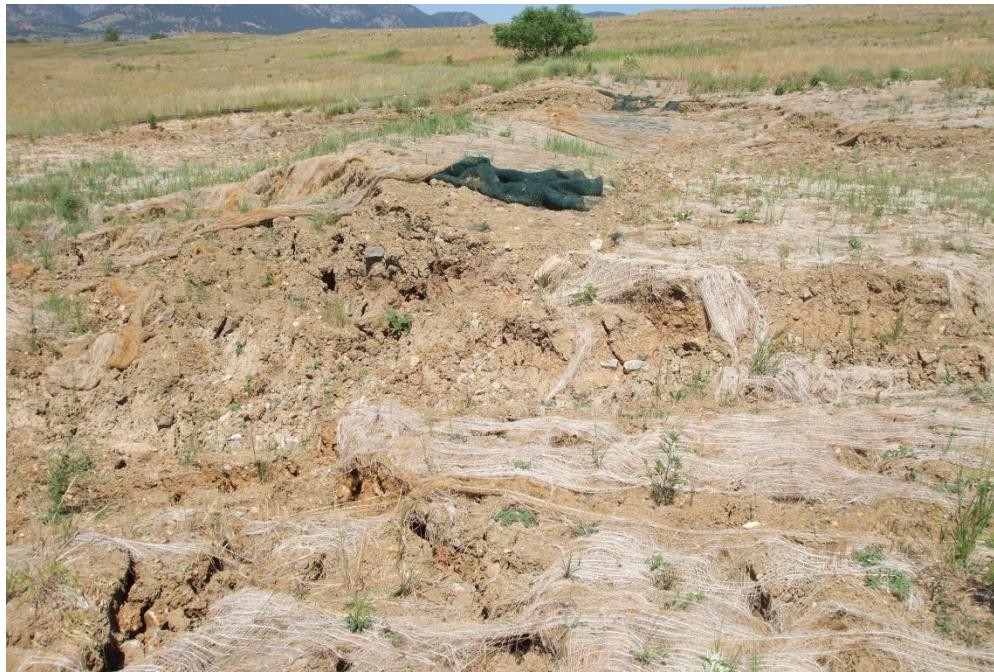
DIVERSION BERM 6	<input checked="" type="checkbox"/> Yes <input type="checkbox"/> No	<input type="checkbox"/> Yes <input checked="" type="checkbox"/> No	<input type="checkbox"/> Yes <input checked="" type="checkbox"/> No	<input type="checkbox"/> Yes <input checked="" type="checkbox"/> No	Cracking through berm from slump
DIVERSION BERM 7	<input checked="" type="checkbox"/> Yes <input type="checkbox"/> No	<input type="checkbox"/> Yes <input checked="" type="checkbox"/> No	<input type="checkbox"/> Yes <input checked="" type="checkbox"/> No	<input checked="" type="checkbox"/> Yes <input type="checkbox"/> No	Cracking through berm from slump

Figure 4: Looking West at the Central Crack and the Crack That Runs Through Berms 6 and 7

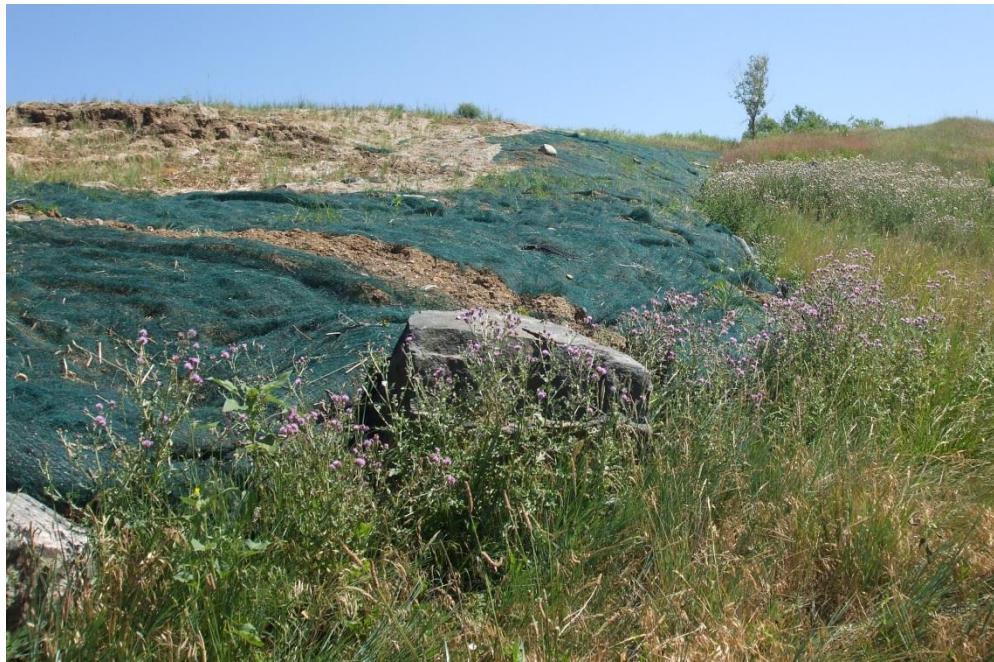
EPC breached due to bank failure caused by slump's toe blocking the EPC. Flow through the breached area is approx. 3-4 gpm and travels down toward Woman Creek

Figure 5: Looking North at the Area of the EPC Outfall that Is Blocked by the Recent Slump

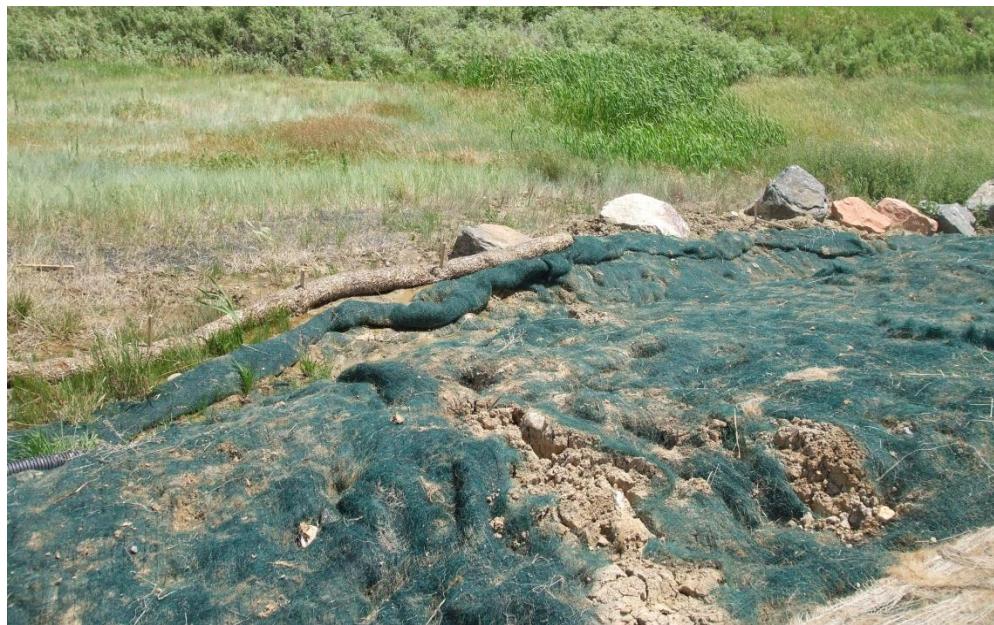
Figure 6: Looking Southwest at the Wet Area Created by Movement of the Toe of the Slump into the EPC

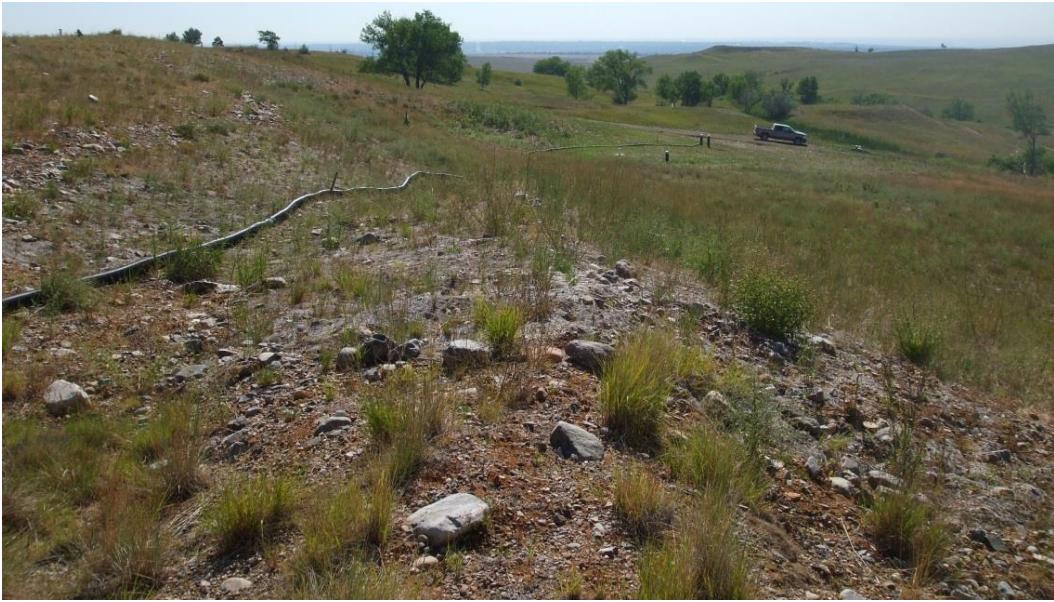
At the time of inspection, the gravity drain line from the groundwater intercept wells was in place and connected to the flow-through line installed in the East Subsurface Drain (ESSD) (Figure 8). Approximately 1 inch of water was observed flowing at approximately 2–3 gpm in the ESSD flow-through line. The ESSD outfall was also flowing at approximately 2–3 gpm.

Figure 7: Looking East, the Gravity Drain Line from the Groundwater Intercept Wells Connects to the Flow-Through Line Installed in the ESSD

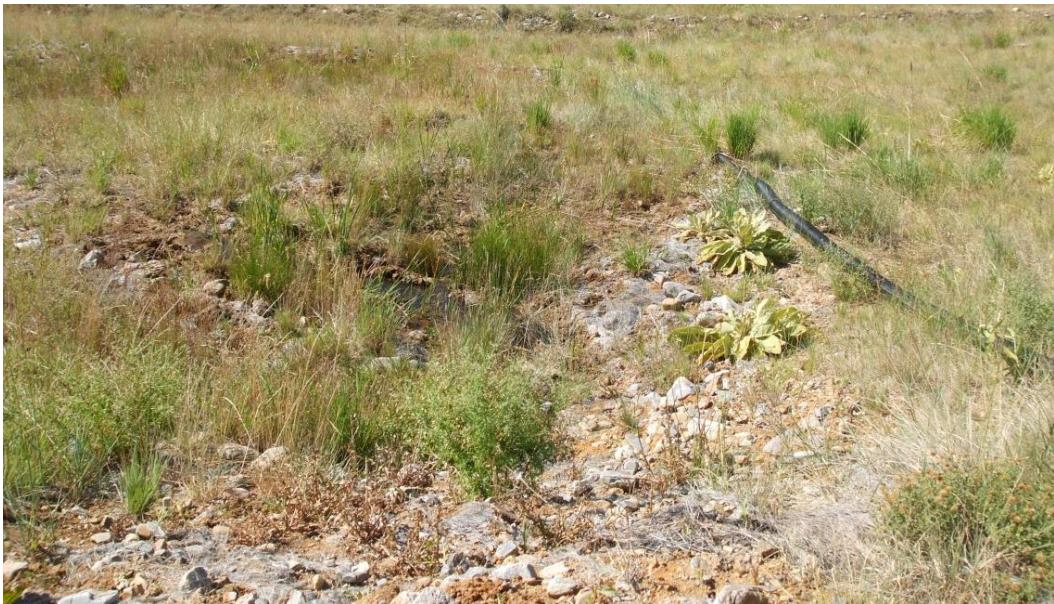
Seeps 9 and 10 had an approximate flow of less than 1–2 gpm. Seeps 7, 8, 8C and a new seep discovered just southwest of seep 10 (Figure 8) have visible water with no flow. Seep 8B was damp. All other historical seep locations were dry at the time of inspection. The new seep will be given an official identifier if visible water persists and the source of water can be confirmed to be from the subsurface. Along the berm 5 channel approximately 150–200 ft west of seep 10, the backfill from a previous crack was eroded. There is no hillside movement associated with this erosion, and maintenance is planned to backfill the crack with hand tools to minimize surface water infiltration.

Figure 8: Looking South at a New Wet Area Just Southwest of Seep 10

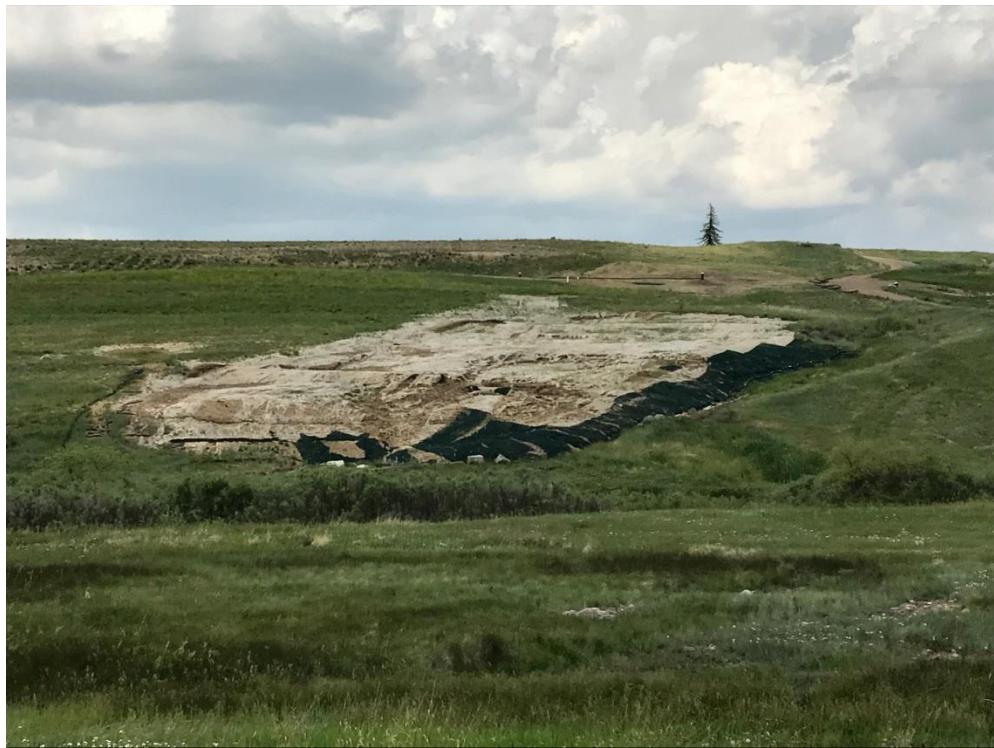
Figure 2: Looking North Toward Slump on Supporting Hillside of the OLF

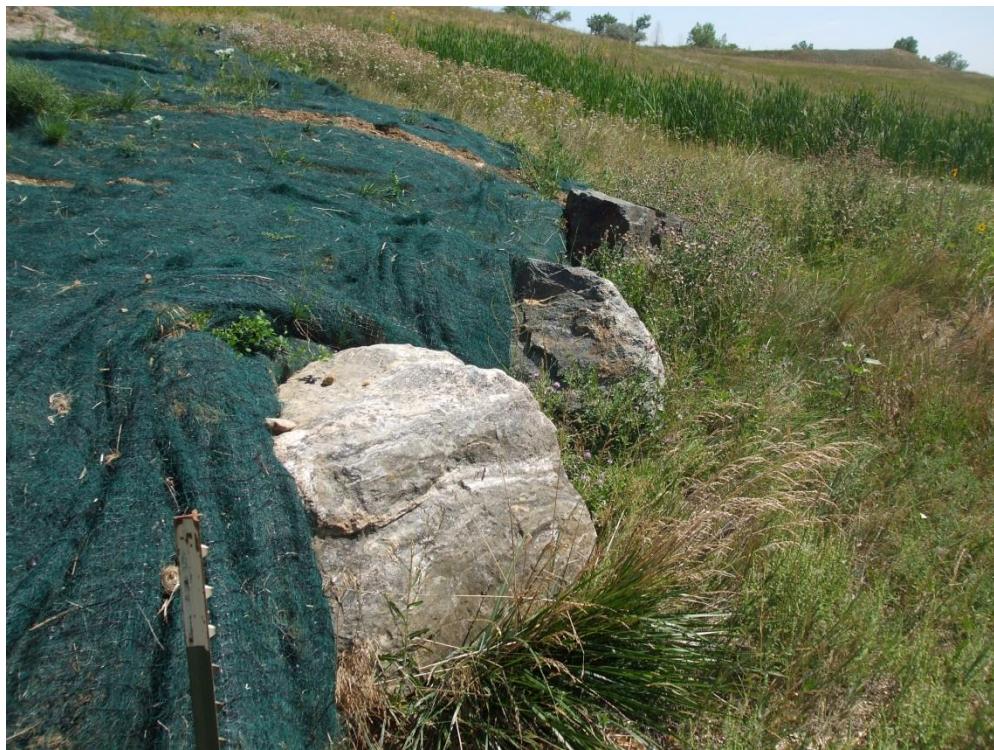
Figure 3: Looking Toward Toe of Slump at Edge of EPC Outfall

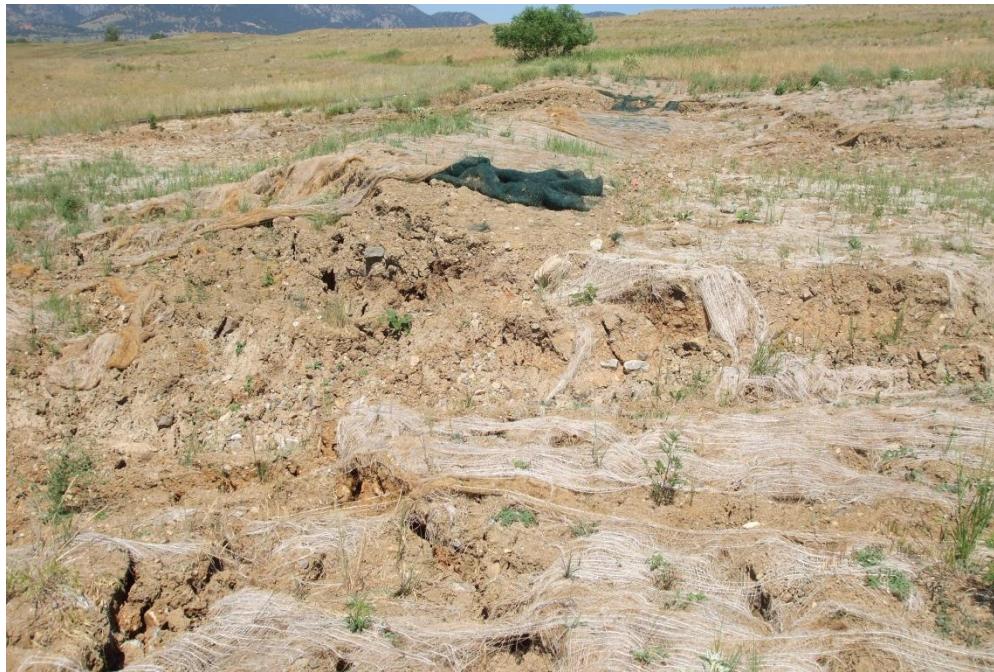
Figure 4: Looking West at the Central Crack and the Crack That Runs Through Berms 6 and 7

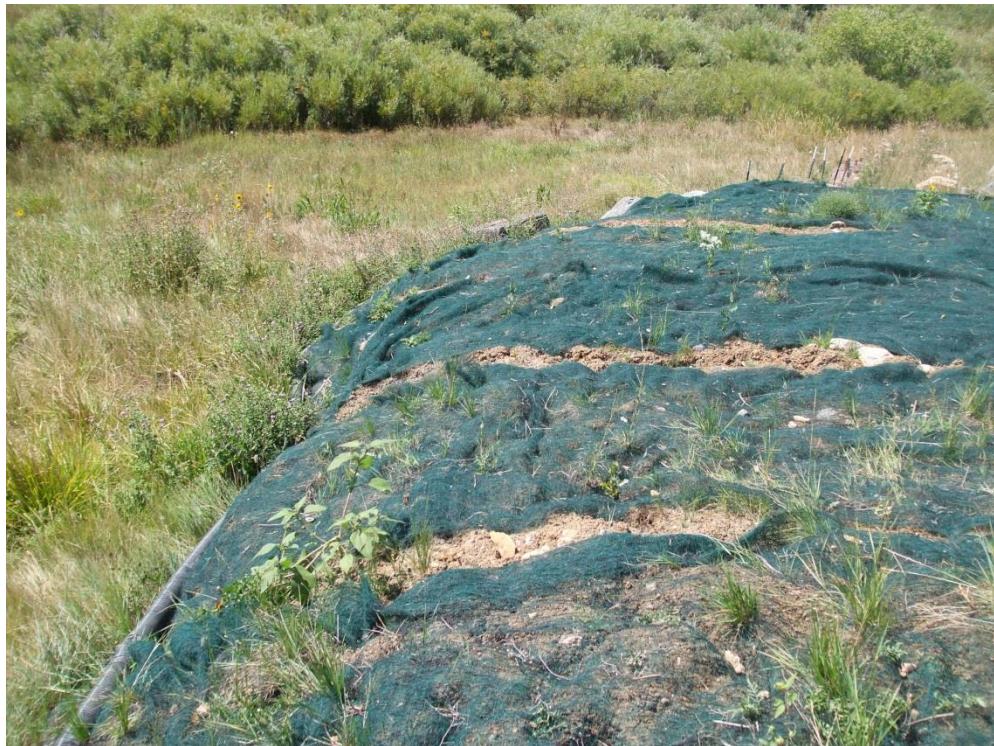
Figure 5: Looking Southwest at the Area of the EPC Outfall that Is Blocked by the Slump

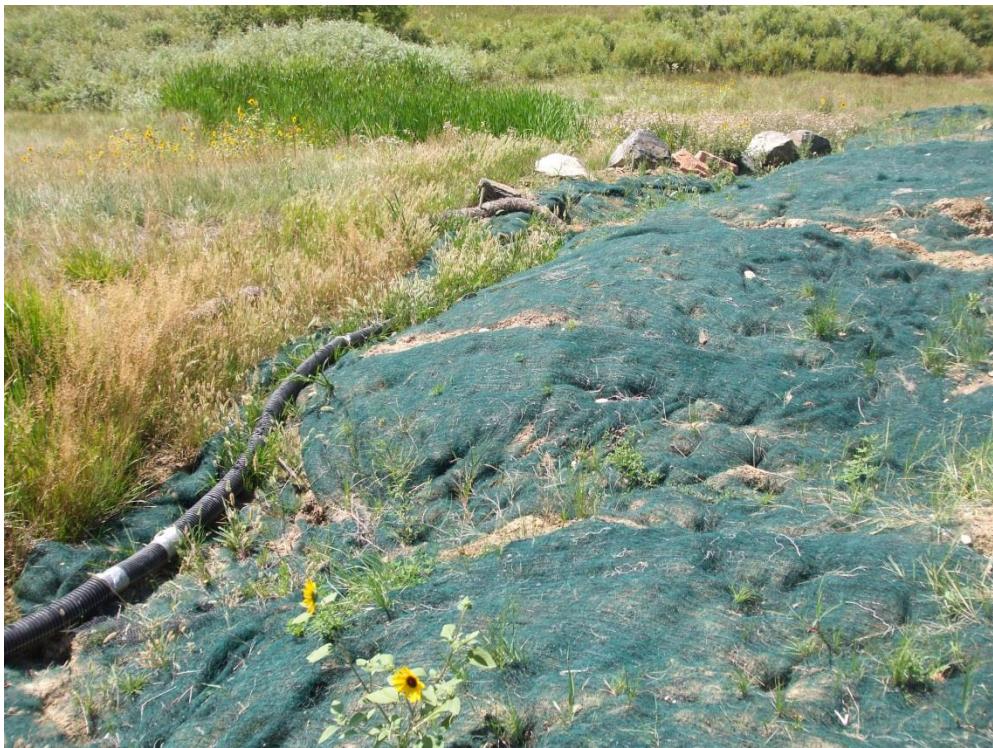
Figure 6: Looking South at the Wet Area Created by Movement of the Toe of the Slump into the EPC

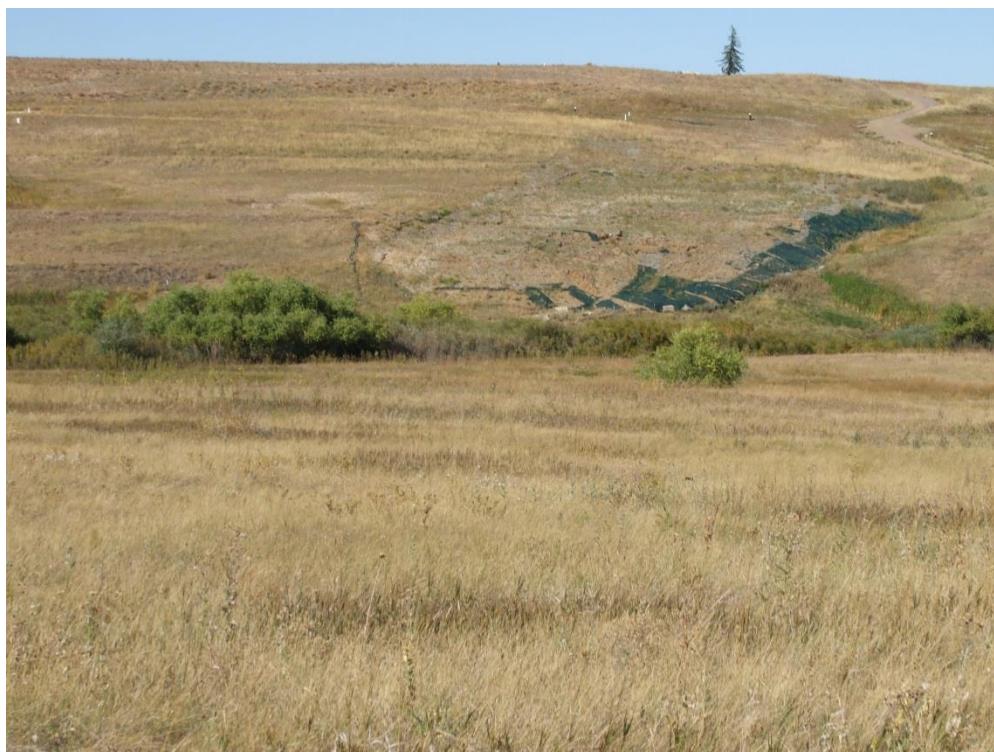
Figure 2: Looking North Toward Slump on Supporting Hillside of the OLF

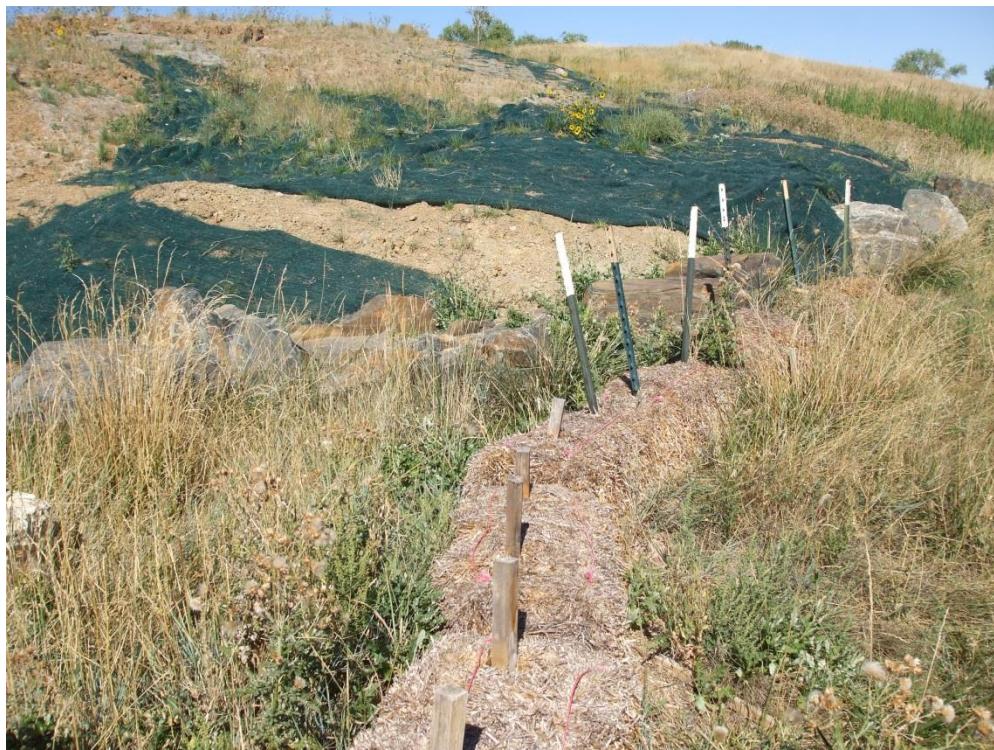
Figure 3: Looking East Toward Toe of Slump at Edge of EPC Outfall

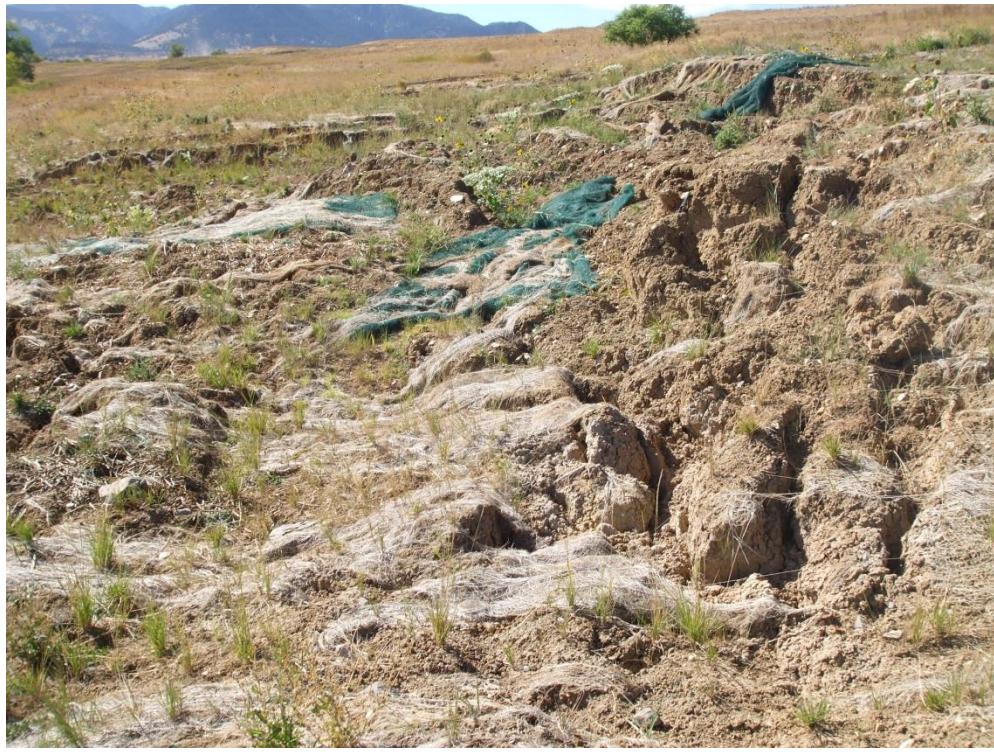
Figure 4: Looking West at the Central Crack and the Crack That Runs Through Berms 6 and 7

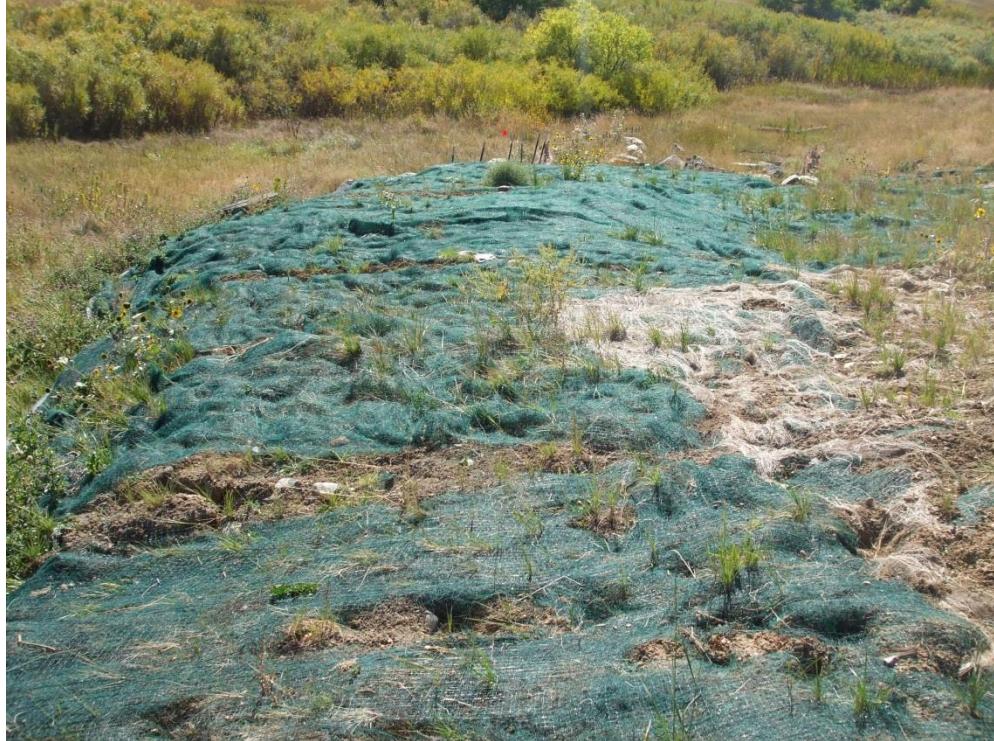
Figure 5: Looking Southwest at the Area of the EPC Outfall That Is Blocked by the Slump

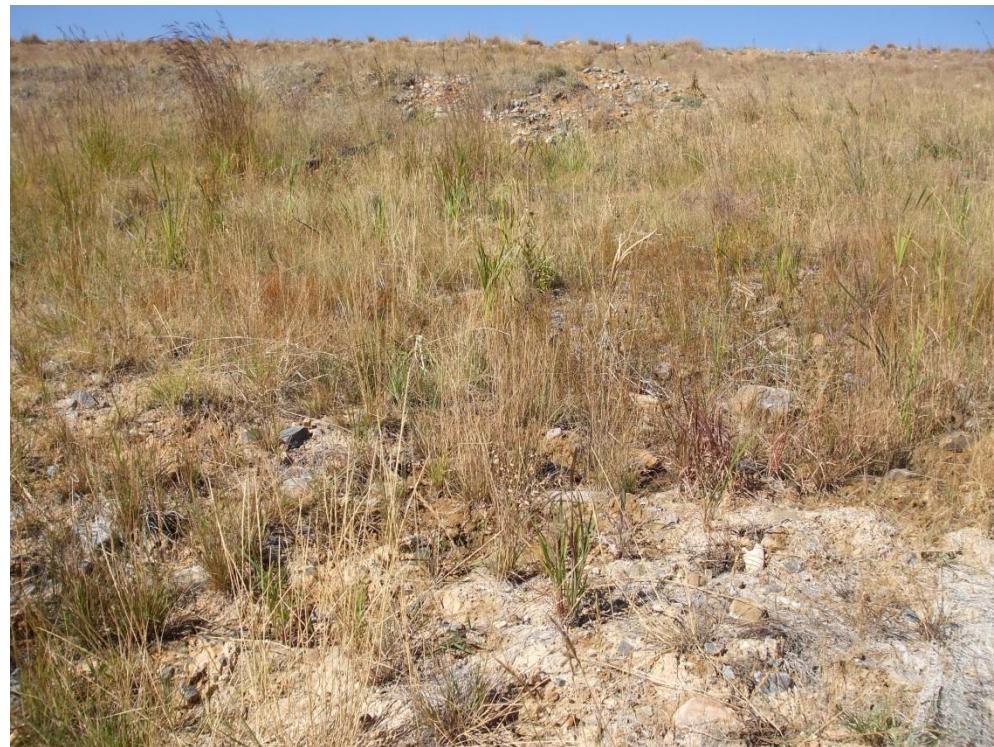
Figure 7: Looking North to the Damp Soil, Middle, Which Is Approximately 30 ft Downgradient of Seep 10A/Berm 5
