# **Rocky Flats Site, Colorado, Quarterly Report of Site Surveillance and Maintenance Activities Third Quarter Calendar Year 2017**

**January 2018**

**U.S. DEPARTMENT OF  
ENERGY**

Legacy  
Management

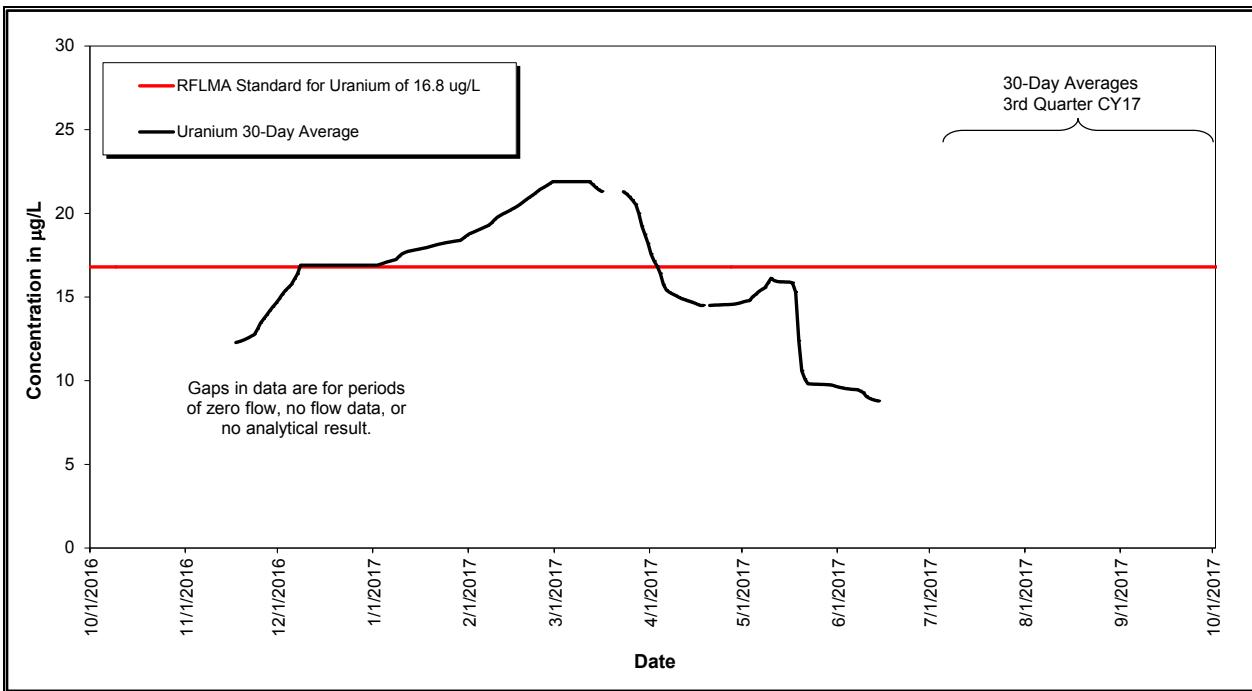
Figure 6 shows that the 30-day average for uranium exceeded the RFLMA standard of 16.8 micrograms per liter ( $\mu\text{g}/\text{L}$ ) during the first quarter CY 2017, triggering a reportable condition and consultation with the regulatory agencies under the RFLMA. A discussion of this reportable condition can be found in the first quarter report (DOE 2017c). As of April 4, 2017, the 30-day average for uranium at WALPOC was no longer a reportable condition. The 12-month rolling average remains below the RFLMA water quality standard for uranium (in  $\mu\text{g}/\text{L}$ , sometimes expressed as ug/L) (Figure 7) using all available data.

**Figure 6. Volume-Weighted 30-Day Average Uranium Concentrations at WALPOC:  
Year Ending Third Quarter CY 2017**

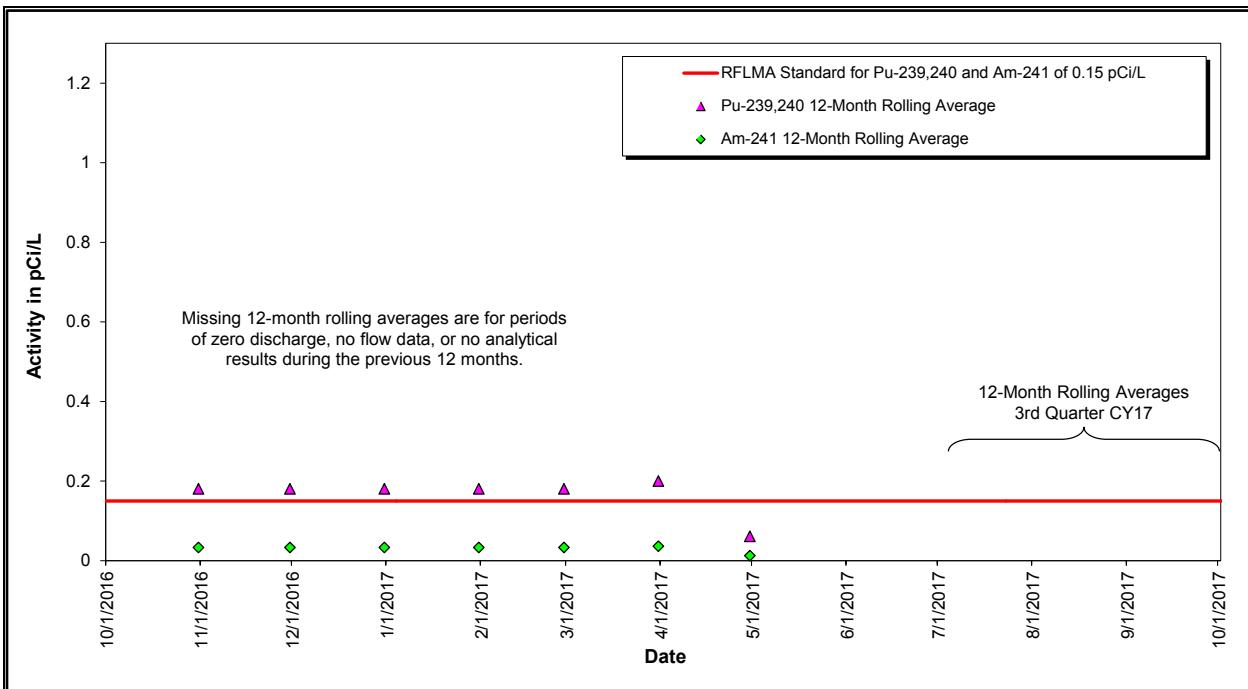
Figure 14 shows that the 12-month rolling average for plutonium exceeded the RFLMA standard of 0.15 pCi/L through March 31, 2017. These 12-month rolling average values for 2017 include water samples back 12 months into 2016. Due to the fact that there was no flow, and therefore no samples collected, at SW027 from June 2, 2016, through April 4, 2017, the 12-month rolling averages in the early part of CY 2017 reflect conditions in 2016.

As of April 30, 2017, the 12-month rolling average for plutonium was no longer a reportable condition. As of the end of the third quarter of CY 2017, the composite sample started on May 23, 2017, was still on progress with only three grabs collected (approximately 0.6 liter, an insufficient volume for analysis). No other analytes were reportable throughout the third quarter of CY 2017.

*Figure 14. Volume-Weighted 12-Month Rolling Average Plutonium and Americium Activities at SW027: Year Ending Third Quarter CY 2017*

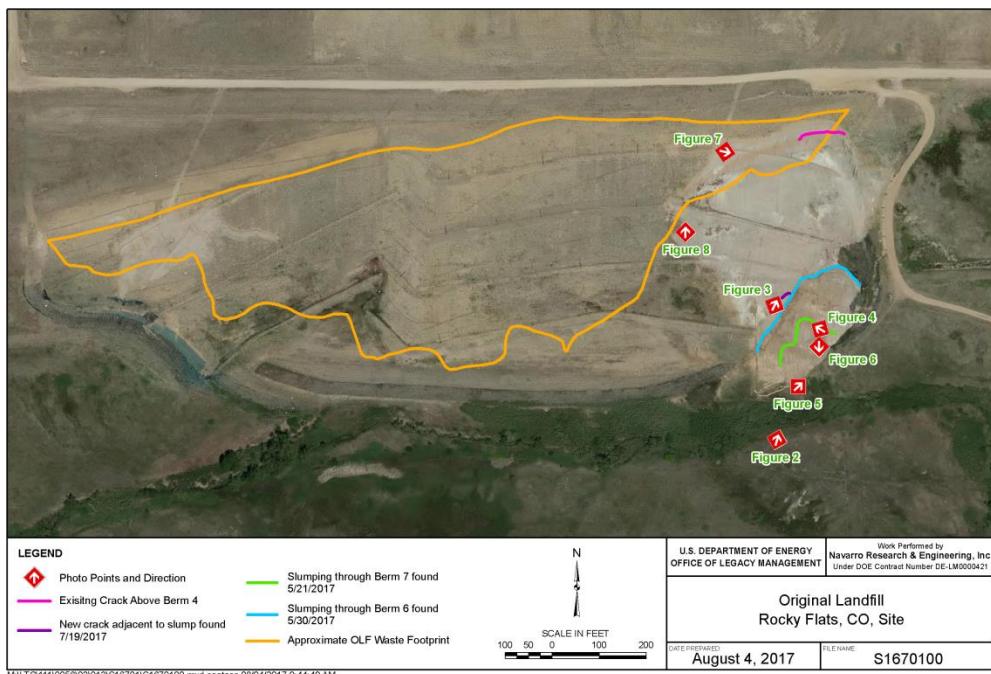
Figure 1 provides the approximate locations from which each of the inspection photographs were taken on the OLF (as shown in Figures 2–8).

**Figure 1: Location and Direction of Each Photograph Cited in This Report  
(Figures 2–9), Original Landfill, Rocky Flats Site, Colorado**

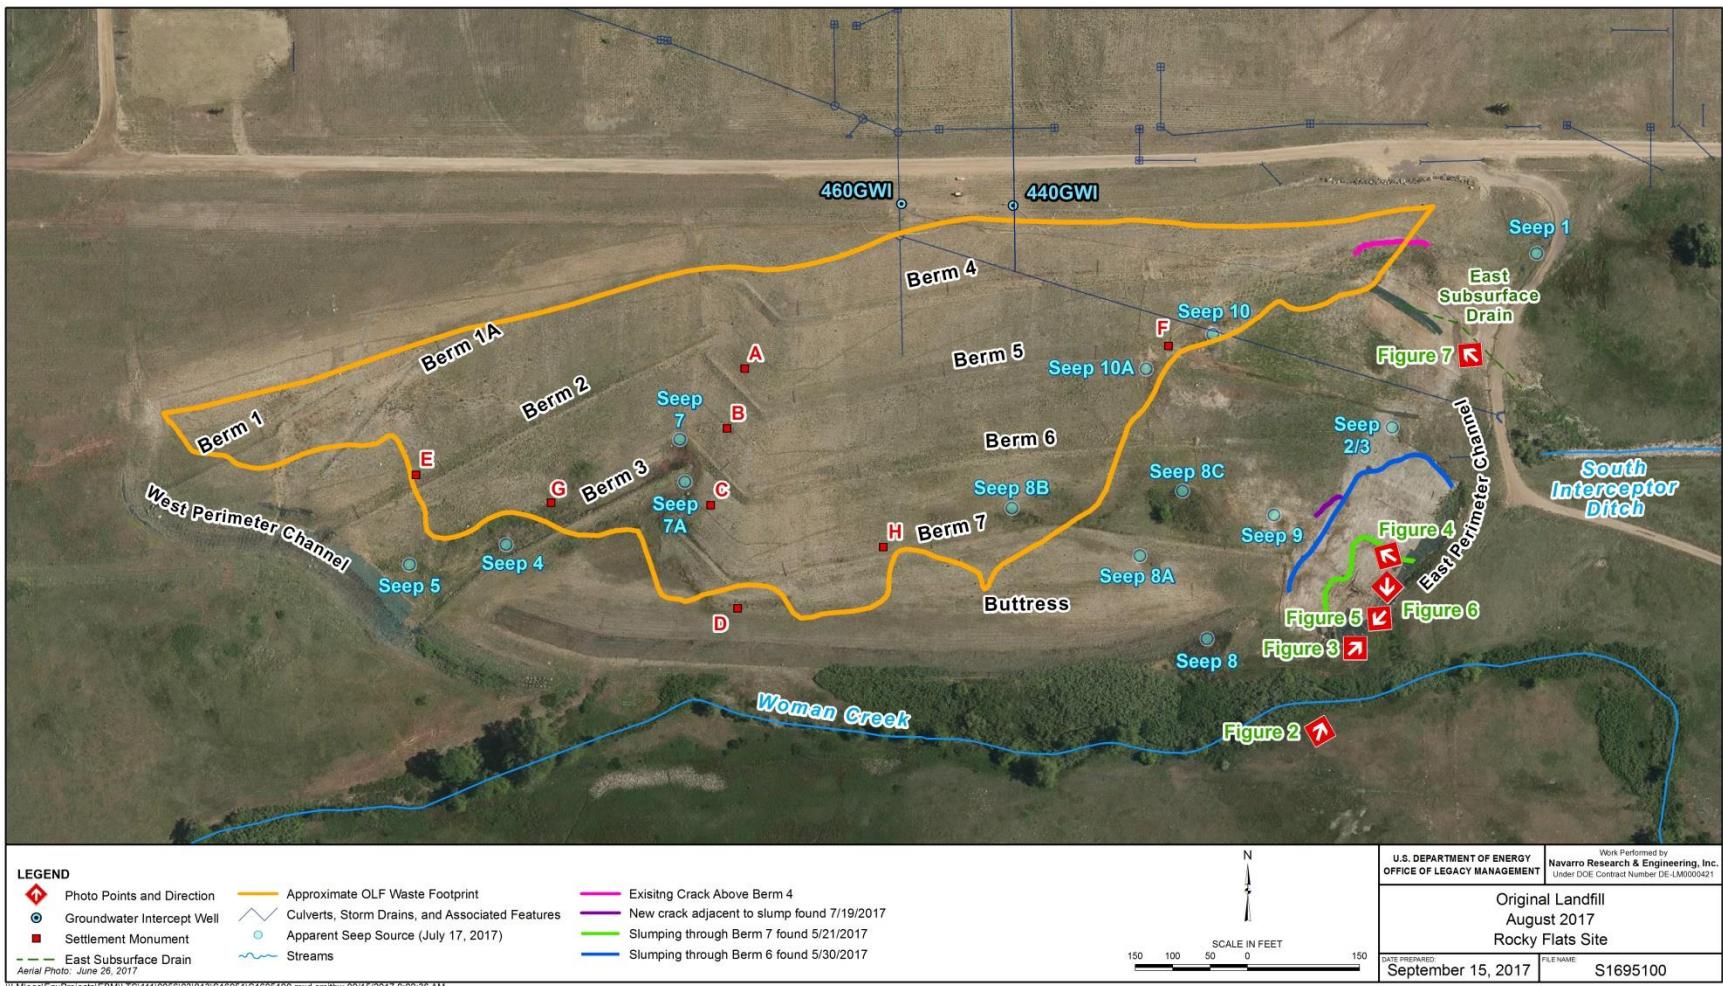
OLF waste footprint (Figure 1). The crack is denoted on Figure 1 as “Existing Crack” because of its original June sighting. It was staked, photographed, and backfilled again on August 9, 2017.

Figure 1: Map of OLF Key Features and the Location and Direction for All Report Photographs, Rocky Flats Site, Colorado

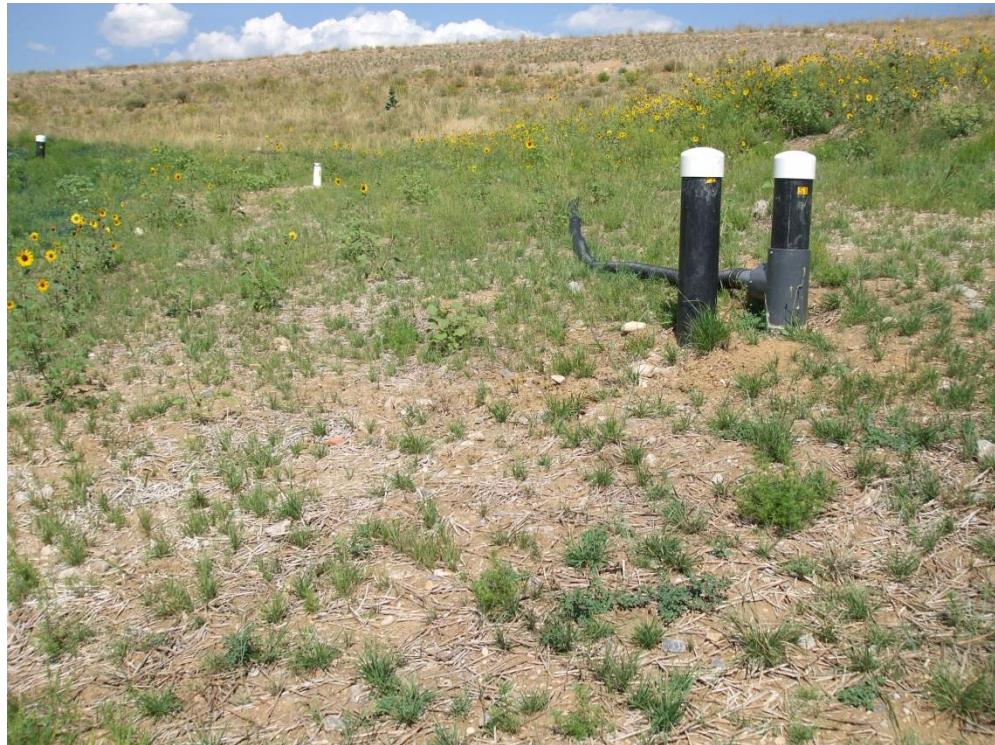
At the time of inspection, the gravity drain line from the groundwater intercept wells was in place and connected to the flow-through line installed in the East Subsurface Drain (ESSD) (Figure 7). Approximately 1 inch of water was observed flowing at approximately 2–3 gpm in the ESSD flow-through line. The ESSD outfall was also flowing at approximately 2–3 gpm.

Figure 7: Looking Northwest, the Gravity Drain Line from the Groundwater Intercept Wells Connects to the Flow-Through Line Installed in the ESSD

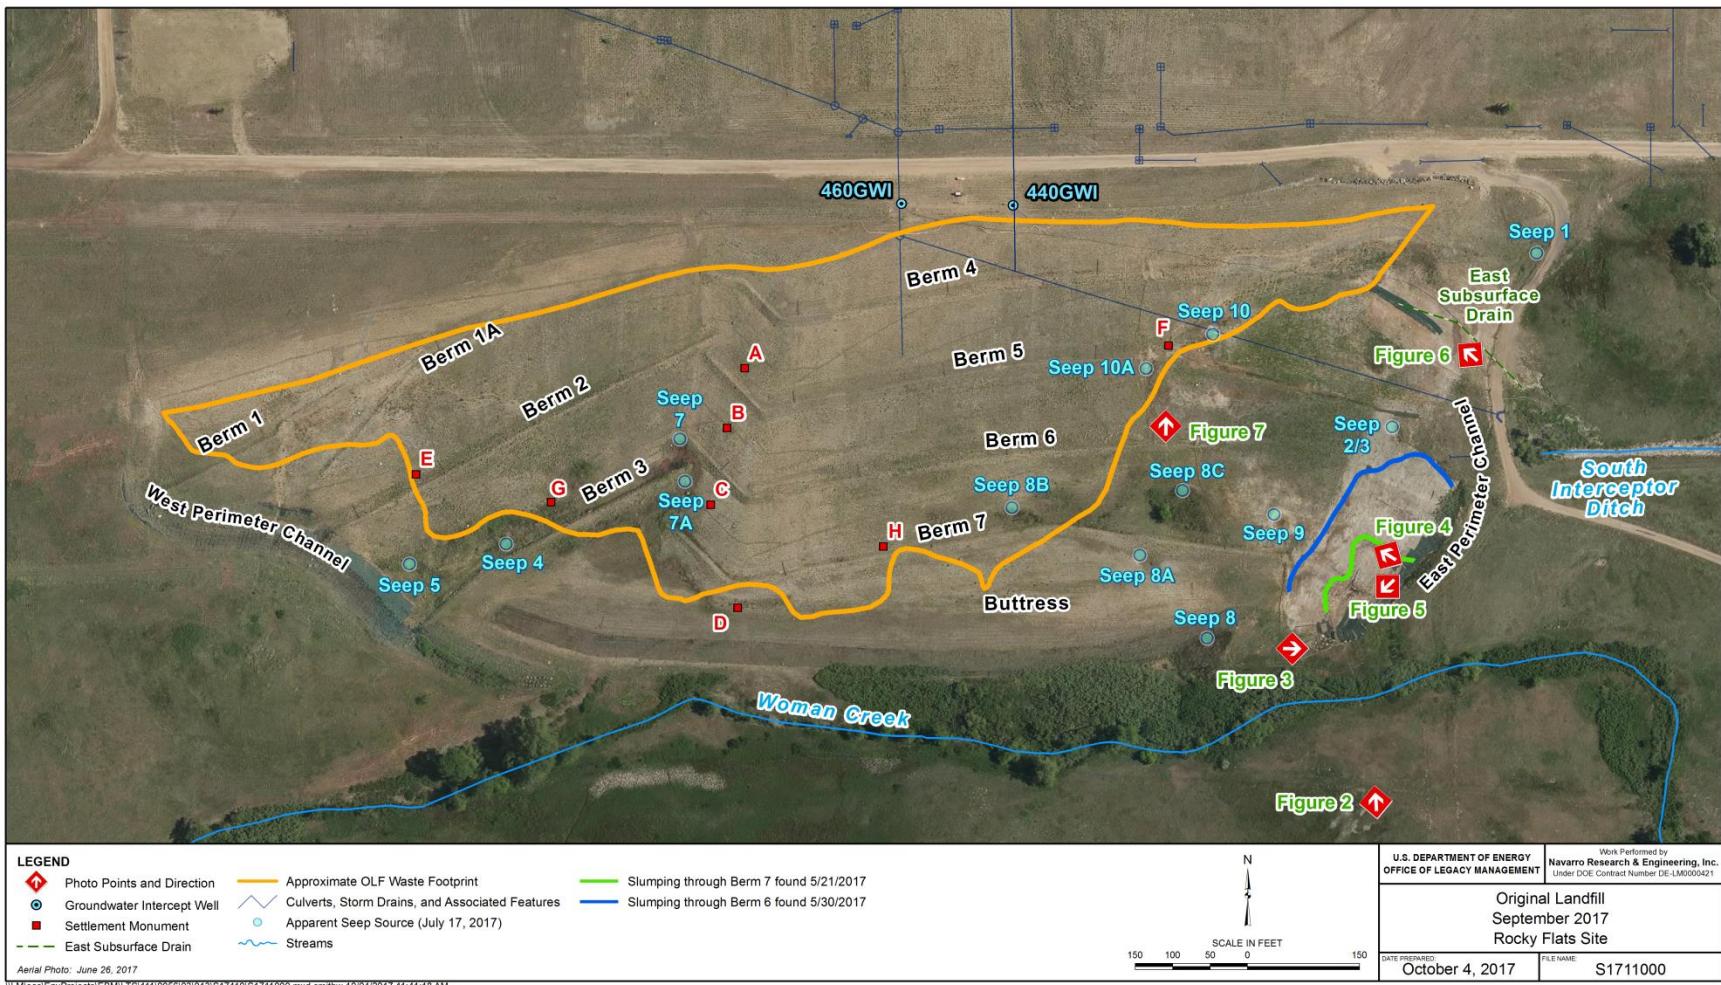
Figure 1: Map of OLF Key Features and the Location and Direction for All Report Photographs, Rocky Flats Site, Colorado

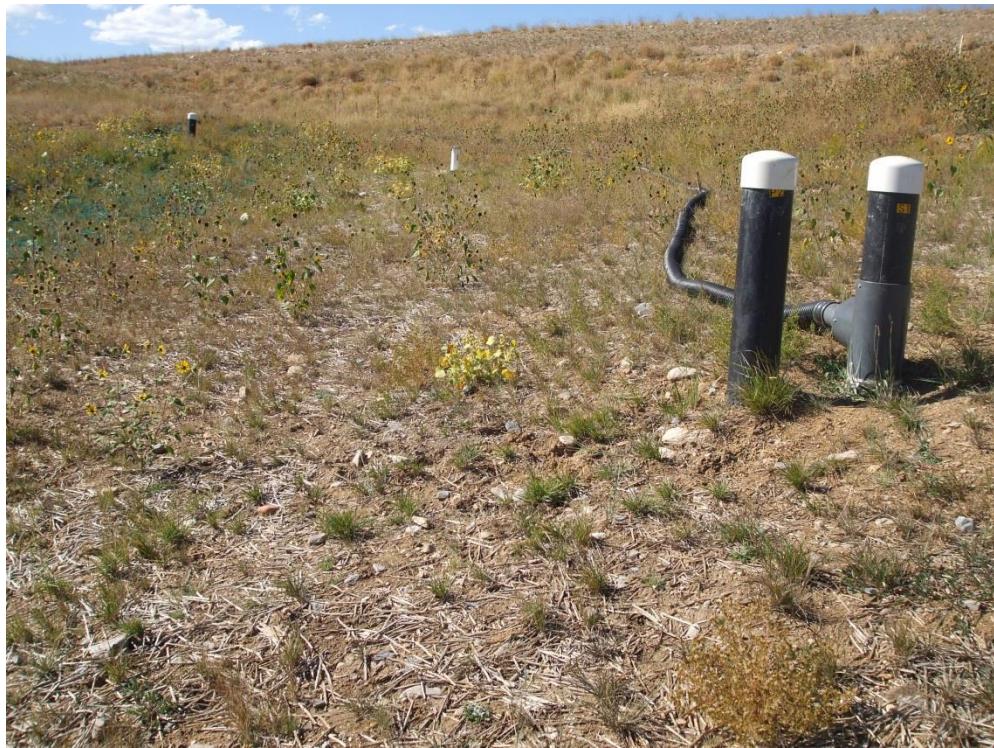
Figure 6: Looking Northwest, the Gravity Drain Line from the Groundwater Intercept Wells Connects to the Flow-Through Line Installed in the ESSD
